# SEAKEEPER CODE 56 DISCUSSION

PRODUCT SEAKEEPER 1 THROUGH 6 MODELS

## PURPOSE

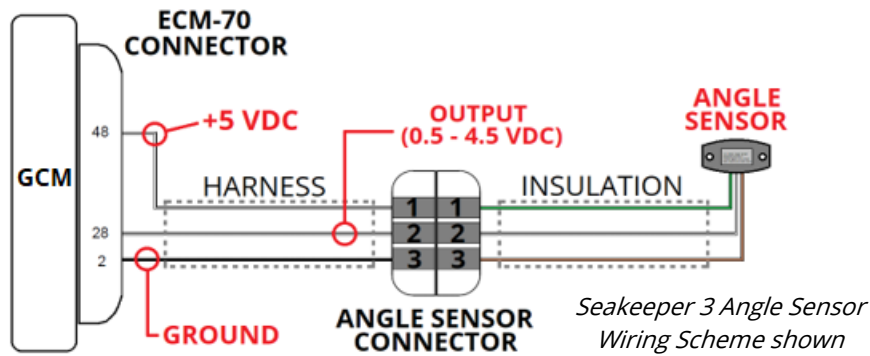
If the angle sensor ground wire were to become disconnected from the GCM, the angle sensor would transmit an angle reading of about 39°. This could result in unintended sphere motion at a high rate and or into its end-stops that would go undetected if not for Code 56. The Code 56 software algorithm seeks to identify this scenario by evaluating if the angle reading has failed to change as expected, given the sea state in which the Seakeeper is operating.

Should a dealer respond to a Code 56 service request, verify the continuity of the ground wire from the angle sensor to the ECM-70 connector (See SWI-106/206 for proper pin numbers). If an open line is found in either the wiring harness or the angle sensor leads, the alarm is valid, and the component should be replaced. Otherwise, the alarm was a nuisance alarm and should be reported to the Seakeeper Product Support Team at support@seakeeper.com.
