PRODUCT SEAKEEPER SERIES MODELS

TROUBLESHOOTING GUIDE TABLE OF CONTENTS

INTRODUCTION

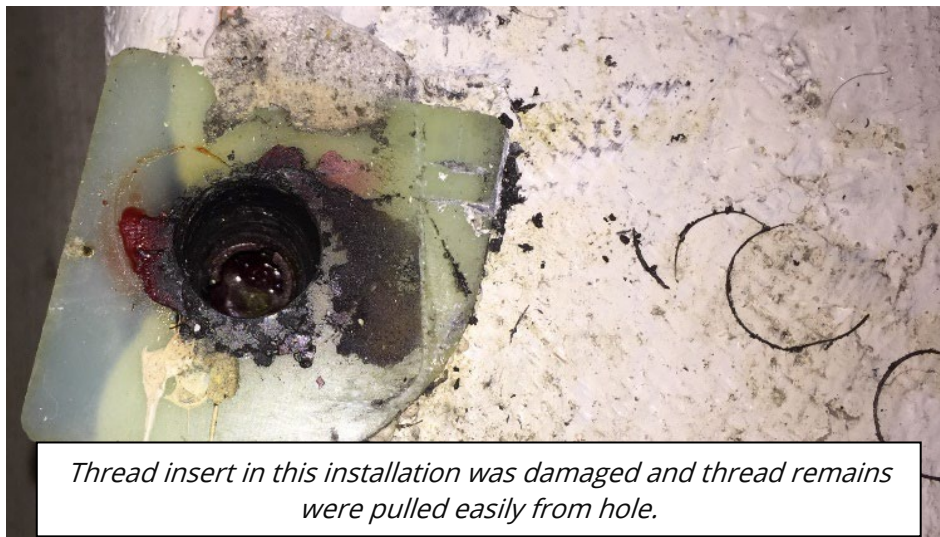
Thread insert in this installation was damaged and thread remains were pulled easily from hole.
